**2018 ROUTINE
BRIDGE INSPECTION REPORT**

**BRIDGE # 7680
CSAH 22 over STONY BROOK**

Date of Inspection: 05/09/2018

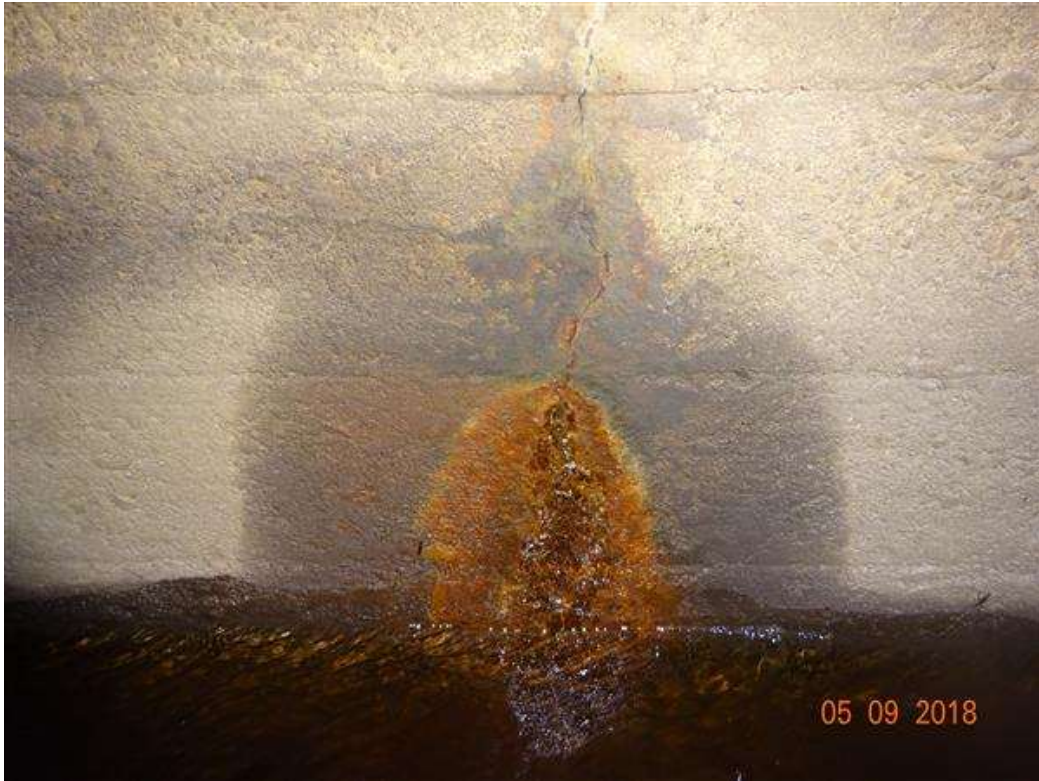
62. Culvert NBI: [2018] Vertical cracks at middle of culverts widening to 0.25" near bottom of wall. Few cracks spaced 2' at middle of barrels.
Minor rust staining present in leaching on vertical cracks barrel 2 east wall. Some form tie holes are leaching, mostly at ends of barrels.
[2017] Few cracks on east wall of barrel 2 have leaching.
[2016] Vertical cracks are 0.02" to 0.125" (most 0.125") with a 4' to 8' spacing. Some cracks widen to 0.5" at base of wall. Light scale on wetted perimeter with no loss of aggregate.
[2015-2013] Water leaching through wall on north end of barrel 2 3' from end. Vertical cracks throughout, open 1/8".

Photo 11 - Barrel 2 East Wall Crack Leaching With Rust Staining

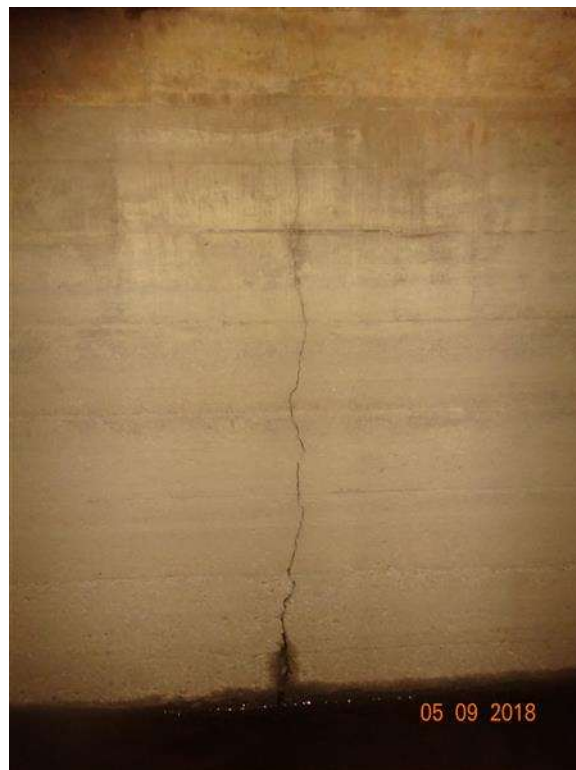
Photo 12 - Barrel Vertical Crack

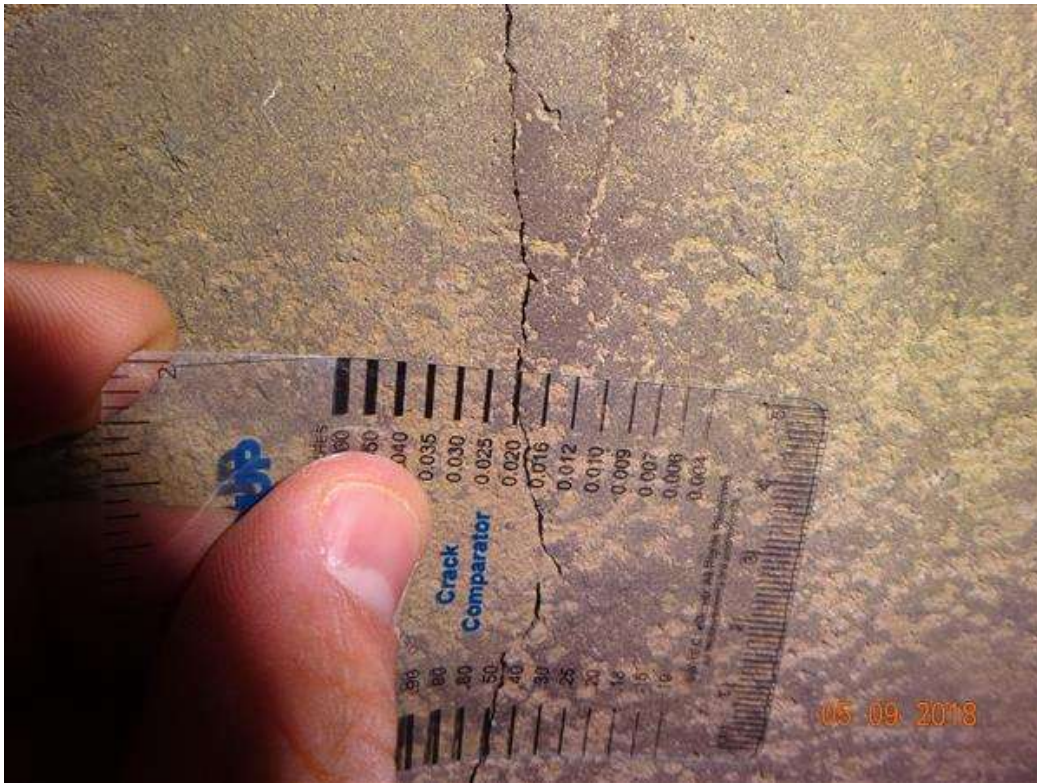
Photo 13 - Barrel Vertical Crack Width 0.02in

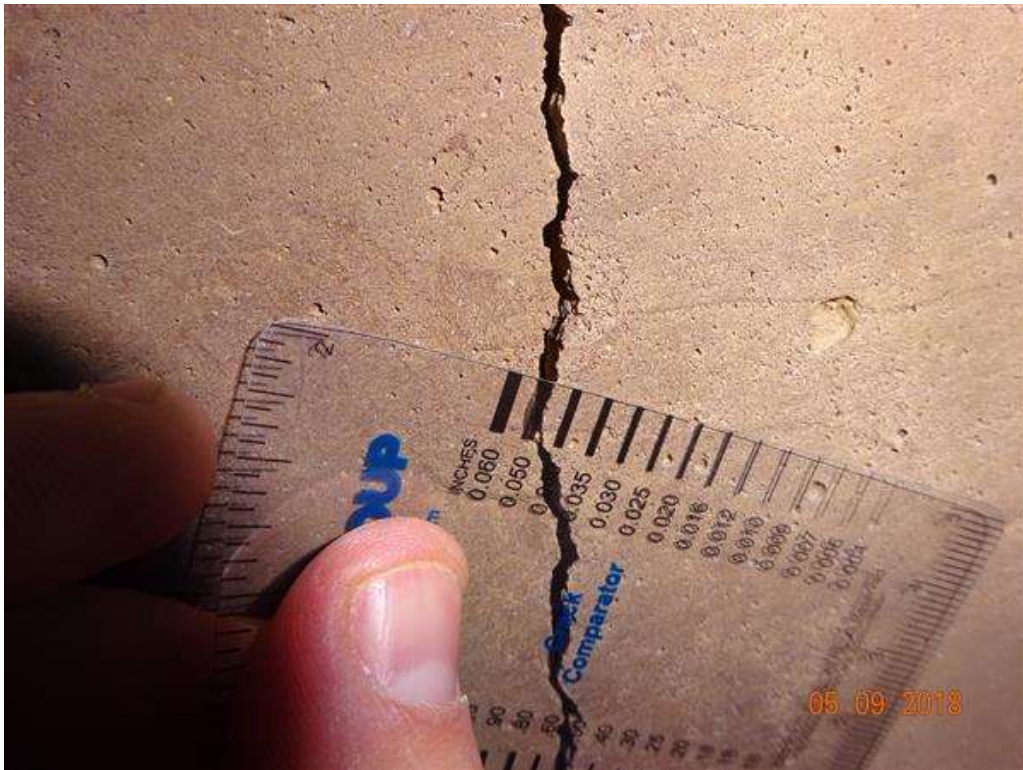
Photo 14 - Barrel Vertical Crack 0.05in

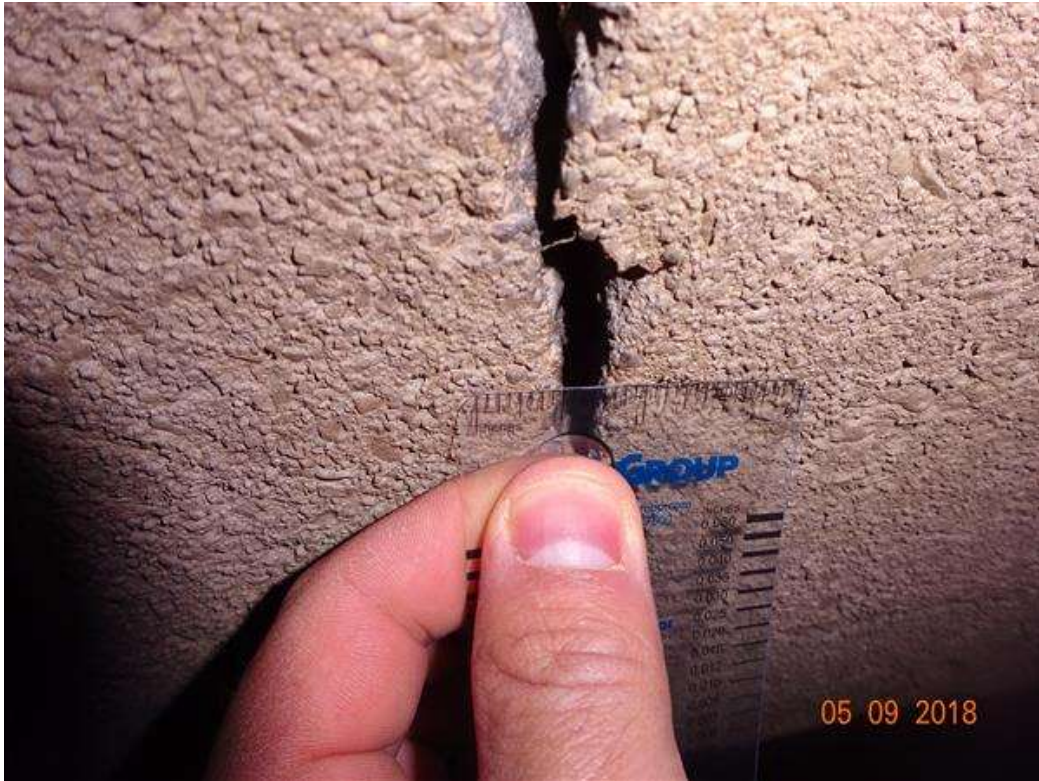
Photo 15 - Barrel Vertical Crack 0.25in at Bottom of Wall

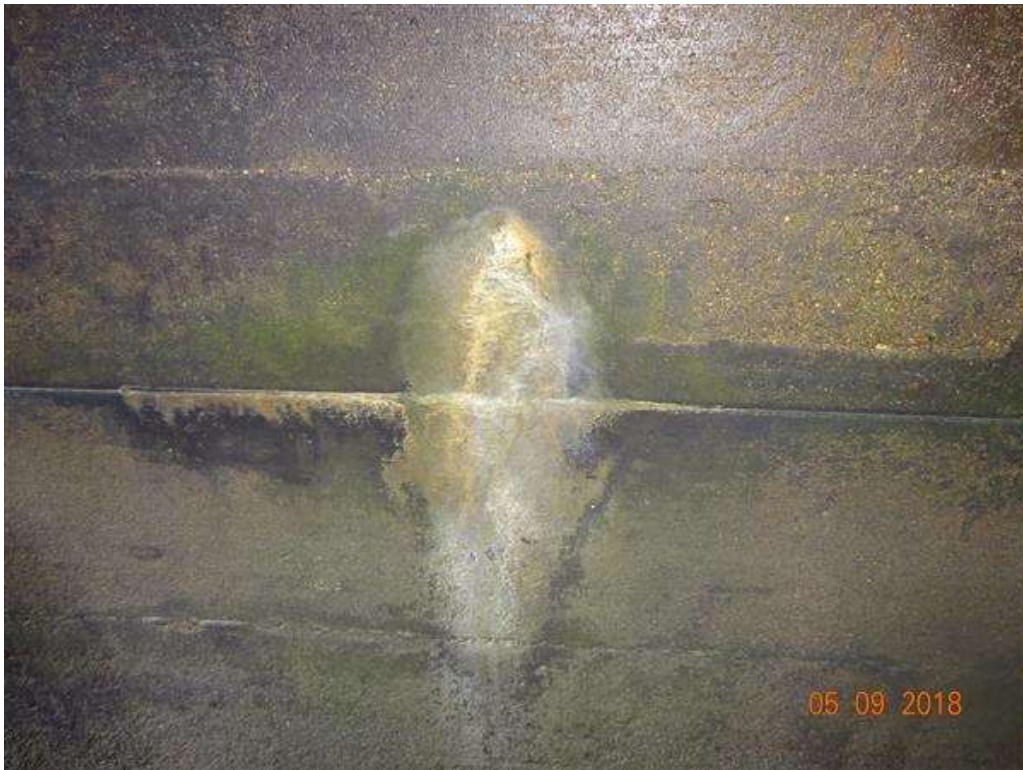
Photo 16 - Barrel Wall Form Tie Hole Leaching

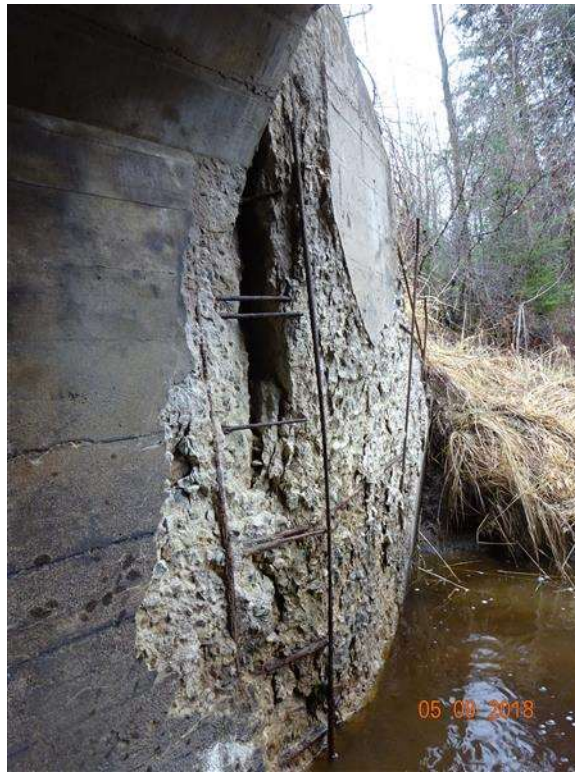
Routine	05/15/2017	1 EA	1	0	0	0
	Notes: [2018-2013] No critical deficiencies or safety hazards found during this inspection.							
870	Culvert End Treatment	Routine	05/09/2018	2 EA	0	1	1	0
		Routine	05/15/2017	2 EA	0	1	1	0
	Notes: [2018-2017] Rebar along joint with wing and barrel on SE failed (Able to see backfill through joint). SE wing has rebar that no longer attached due to delamination and tie wire rusting away. Rebar has up to 50% section loss.							
	[2016] SE wing has pushed in 3" to 4". 1 0.125" diagonal crack on SW and NE wings. Spalling along top of south center wing with no exposed rebar.							
[2015-2013] The surface of SE wing has delaminated and spalled exposed rebar which is corroding and no longer encased in concrete in some locations.								
S curb spalled.								
Minor cracking in wingwalls. NE & SE leaching. Spall SE wing with extensive rebar exposure. Cracks in NE, SE & SW wings.

Photo 20 - SE Wing and Barrel Connection Failure

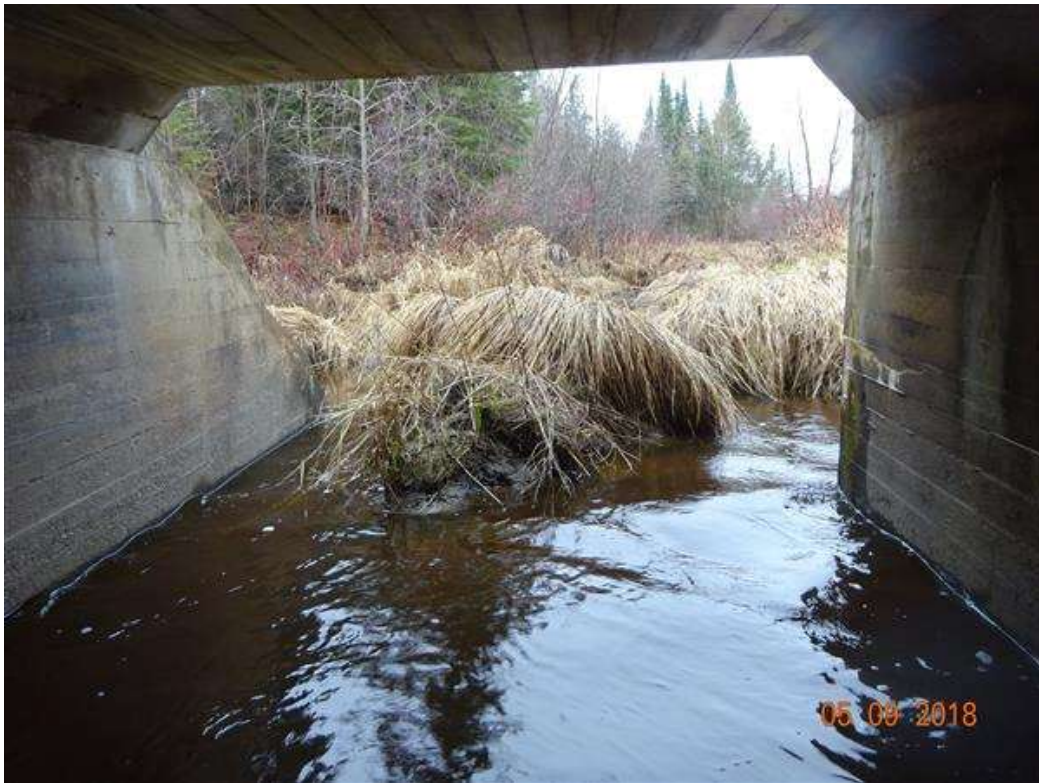
61. Channel NBI: [2018-2016] Bank slump north end of barrel 1 blocking 50% of outlet. Sediment buildup of 2' in some areas.
[2015-2013] Banks at inlet and outlet of barrel 1 have slumped in blocking some of the flow of barrel 1.

Photo 27 - Barrel 1 Inlet Blockage
